AE911Truth Challenges NIST’s WTC 7 Floor 12 Fire Analysis

Architects and Engineers for 9/11Truth
Submitted by Chris Sarns
Progression of fire on Floor 12 of WTC 7
(consistent with photographs)

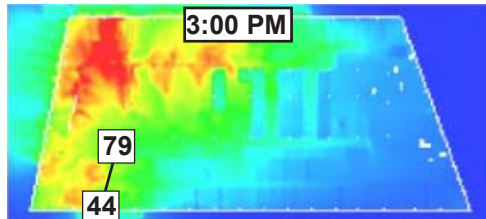
NIST NCSTAR 1-9, Vol. 2, page 383
Figure 9-11. Progression of simulation
fire on Floor 12 of WTC 7.
(NOT consistent with photographs)

According to NIST, the fire on floor 12 caused the girder between columns 79 and 44 under floor 13 to fail at 5:20 PM. Theoretically, this was the beginning of the initiating event that led to the implosion of WTC 7.

On page 383 of NIST NCSTAR 1-9 Vol. 1 (2008), the fire simulations graphic of floor 12 shows the fire burning around column 79 at 4:00 and 5:00 PM. The NIST simulation is not consistent with the photographs of the fire. The photographs show, and the NIST Appendix L report (2004) states “Around 4:45 PM, a photograph showed fires Floors 7, 8, 9, and 11 near the middle of the north face; Floor 12 was burned out by this time.” In fact, it had burned out in the east end before 4:00 PM.

Therefore, the fire on floor 12 could not have caused floor 13 to collapse (at 5:20 PM) and the implosion of WTC 7 could not have occurred as NIST has proposed.
